Feasibility Study for the Veterans Memorial Coliseum

Marshalltown, Iowa

FACILITY ASSESSMENT

Veterans Memorial Coliseum Marshalltown, Iowa

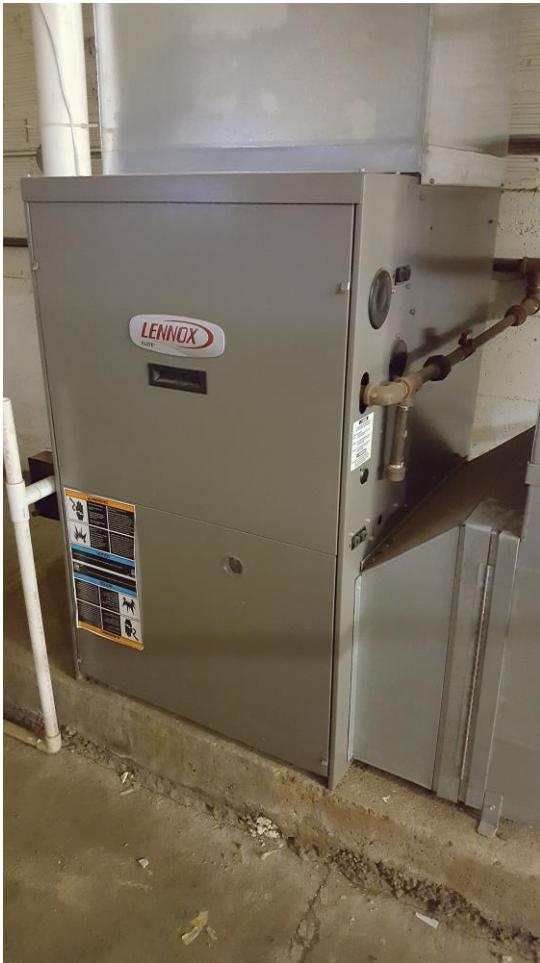
The boiler has since been removed and replaced with six Lennox forced-air, natural gas furnaces. Two of these furnaces currently only serve office areas on the first floor. These two furnaces are relatively new (< 5 years old) and appear to be in proper working order. Much of the original steam piping has been cut out.

Figure 1: Office area furnace

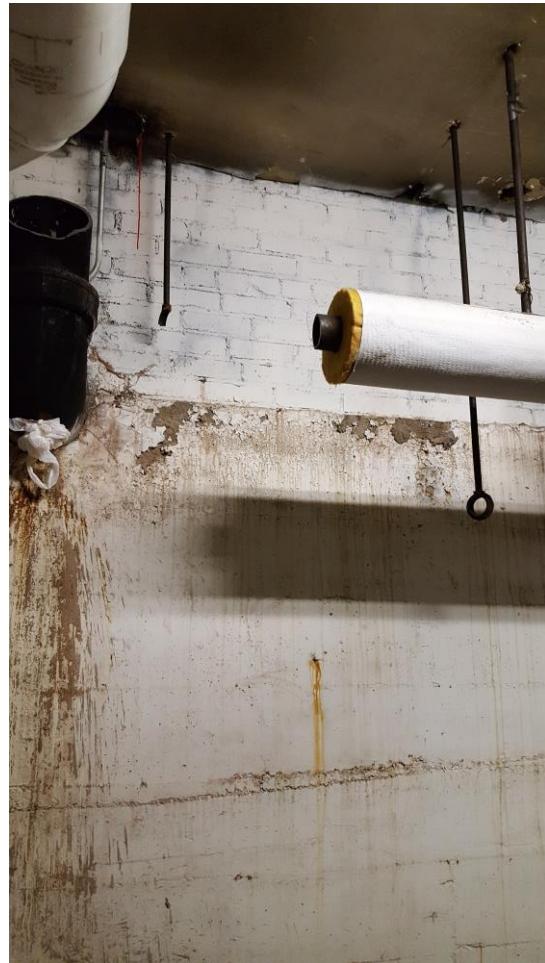
Originally, the building was heated by a coal-fired steam boiler that provided low pressure steam to cast-iron radiators throughout the building. The office area still has some of the original steam radiators. None of the radiators appear to have leaks, so these could potentially be re-used as part of a renovation project to preserve some of the building's history.

Figure 2: Cut steam piping

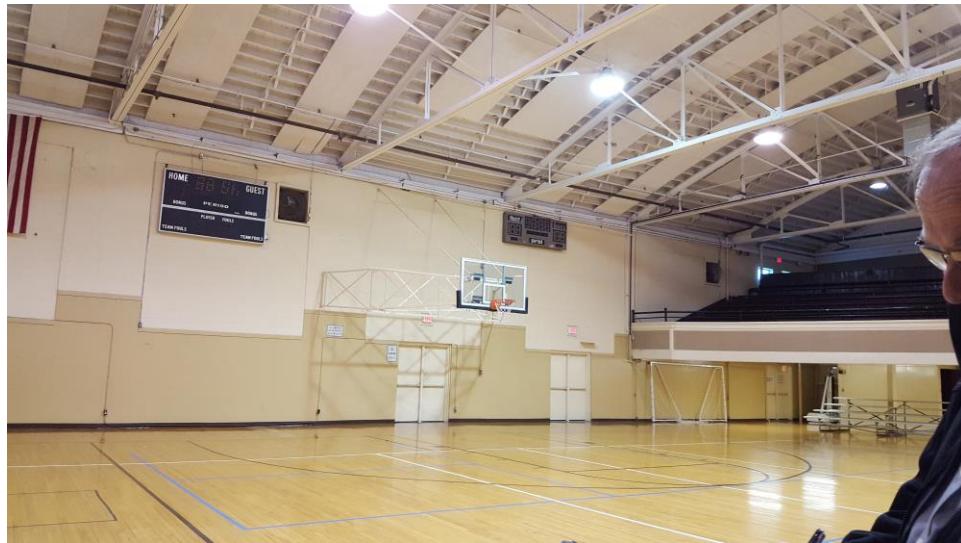
The other four furnaces serve the Gym. The Gym furnaces are installed high above the Gym floor in a downward airflow configuration. These pull air from the ceiling and blow air straight down to the floor. The Gym furnaces are all relatively new and are in proper working order. The location of these furnaces make regular maintenance and filter changes very challenging.

Six propeller-type exhaust fans in the Gym can provide some indirect cooling by inducing unconditioned fresh air into the space through exterior doors. The exhaust fans are currently functional.

Figure 3: Gym area showing exhaust fans, exterior doors, and furnace.

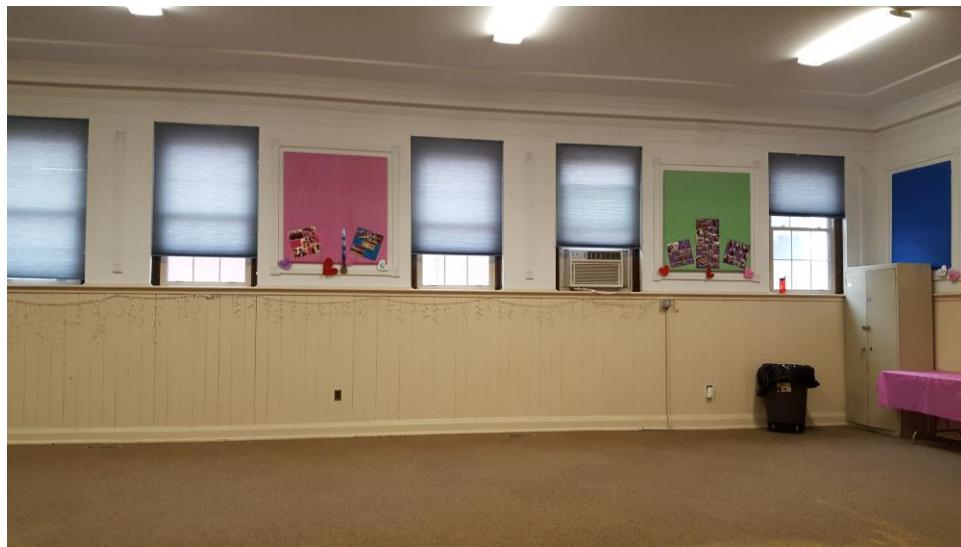
The building has no active or mechanical air conditioning aside from two small window mounted air conditioners that serve one room (the Blue Room) on the first floor.

Figure 4: Blue Room showing window-mounted air conditioner

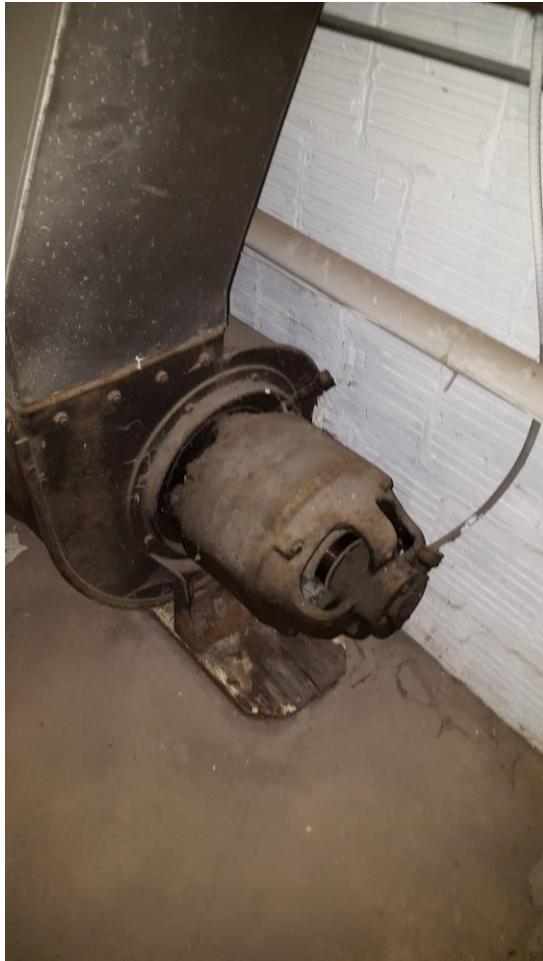
The building also has some small bathroom exhaust fans and associated ductwork. The bathroom exhaust fans themselves use antiquated motors and were not in operation during our site visit. There has also been some plumbing and electrical modifications performed that destroyed the integrity of the exhaust ductwork.

Figure 5: Antiquated restroom exhaust fan

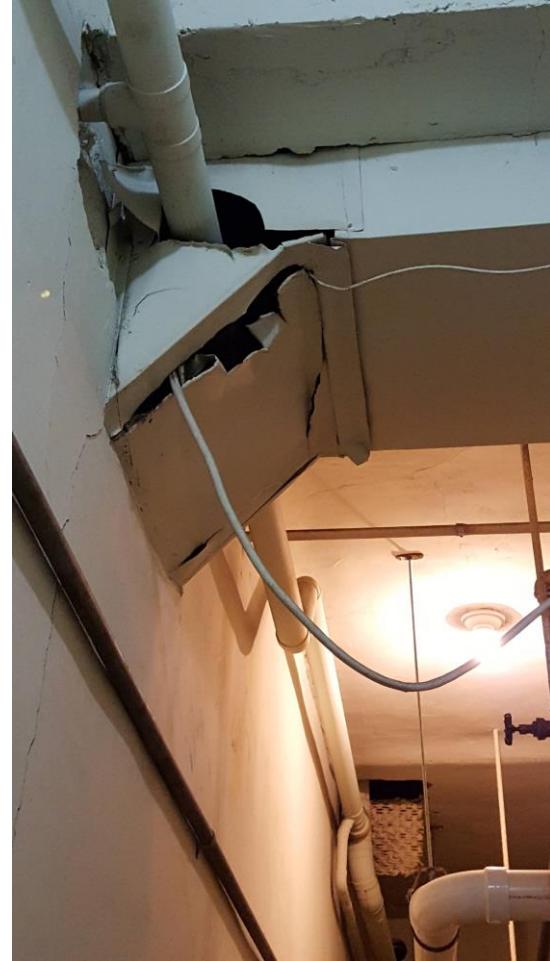
Figure 6: Damaged exhaust ductwork

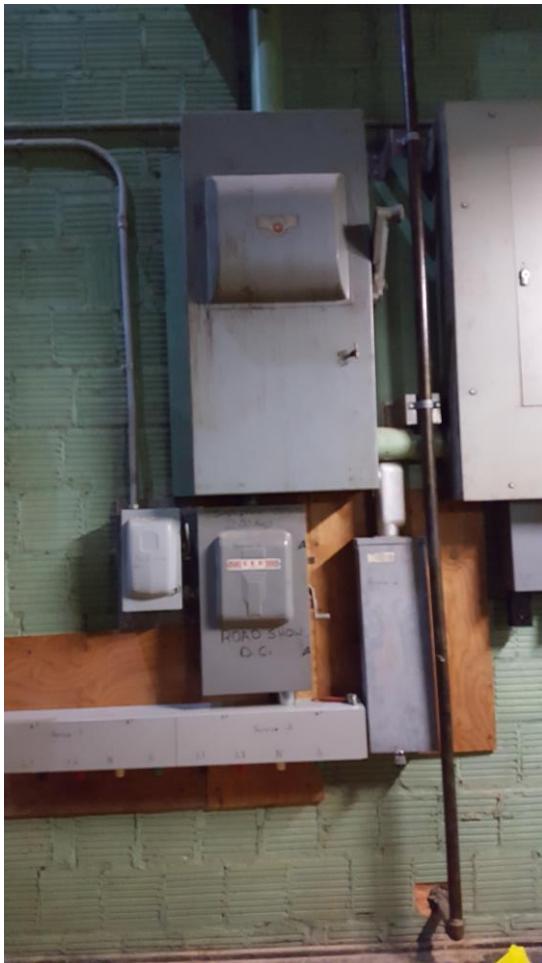
Over the years, the building's electrical service has been expanded and split into subpanels multiple times. The main electrical service is currently a 208 volt, 3 phase, 800 amp service. The building also has a working 10 kW backup generator. The generator only serves the front office area for emergency lighting.

The electrical panels appear to be in good working order. Many panels utilize older circuit protection technology. The city has already inquired about upgrading these panels to modern circuit protection technology.

Figure 7: Main electrical panel

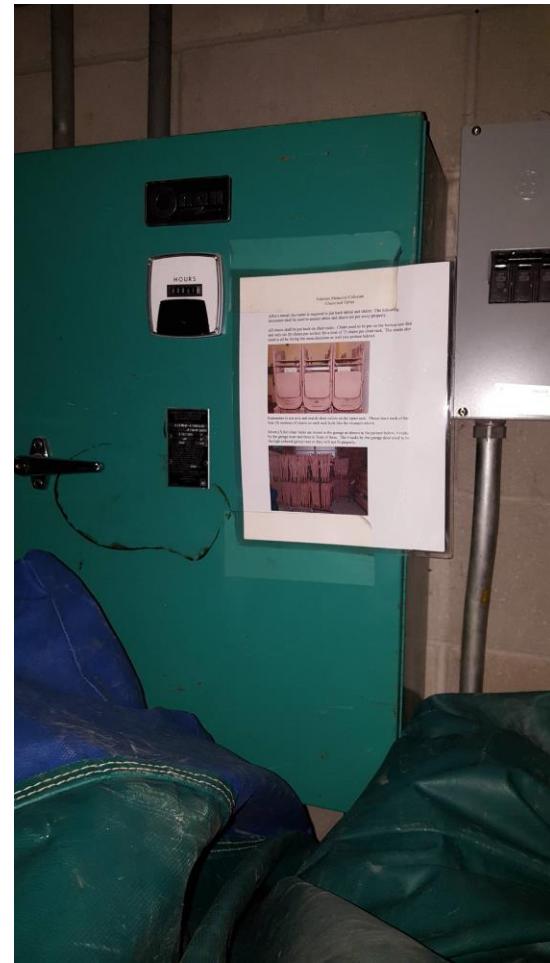
The backup generator appears to be well maintained and tested.

Figure 8: Backup generator

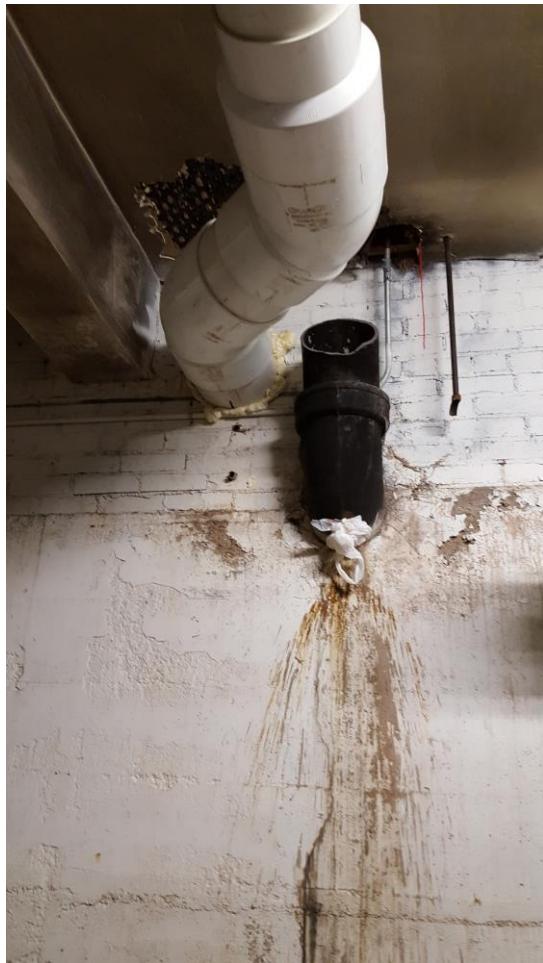
The plumbing systems in the building appear to have undergone various upgrades and modifications over the years. Many of the drainage (sewer and roof drain) systems have been updated from cast-iron to PVC piping. The domestic hot water system also appears to have been updated recently with a modern, natural gas hot water heater & tank.

Figure 9: Updated PVC piping next to out-of-service piping

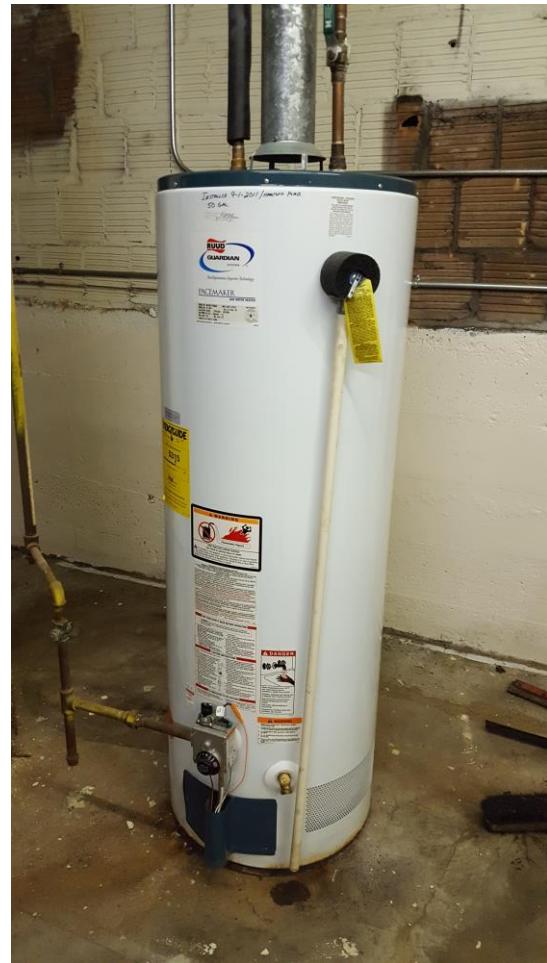
Figure 10: Natural gas hot water heater

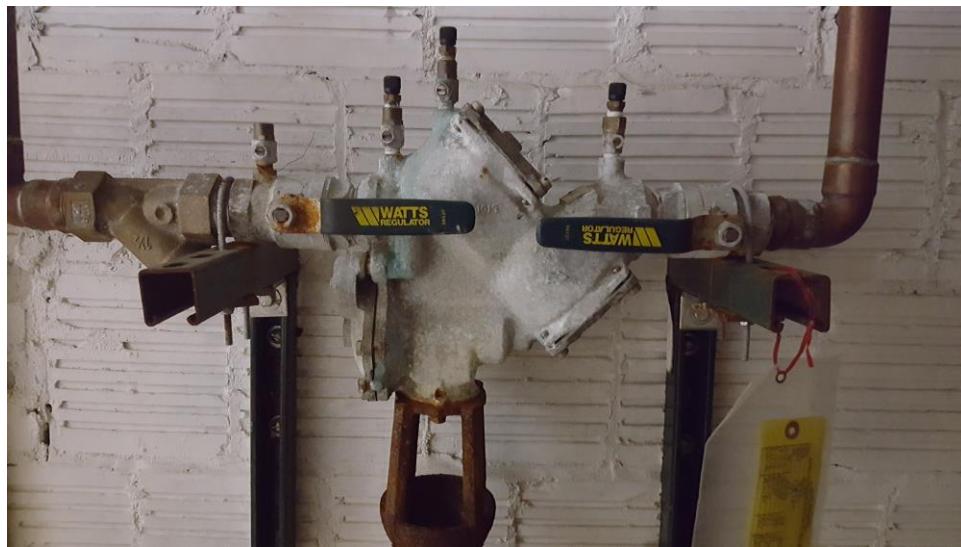
The domestic supply water appears to be in decent shape. Much of the existing copper piping could potentially be re-used under a renovation project. City provided water meter and backflow preventer both appear to be fully functional.

Figure 11: Backflow preventer

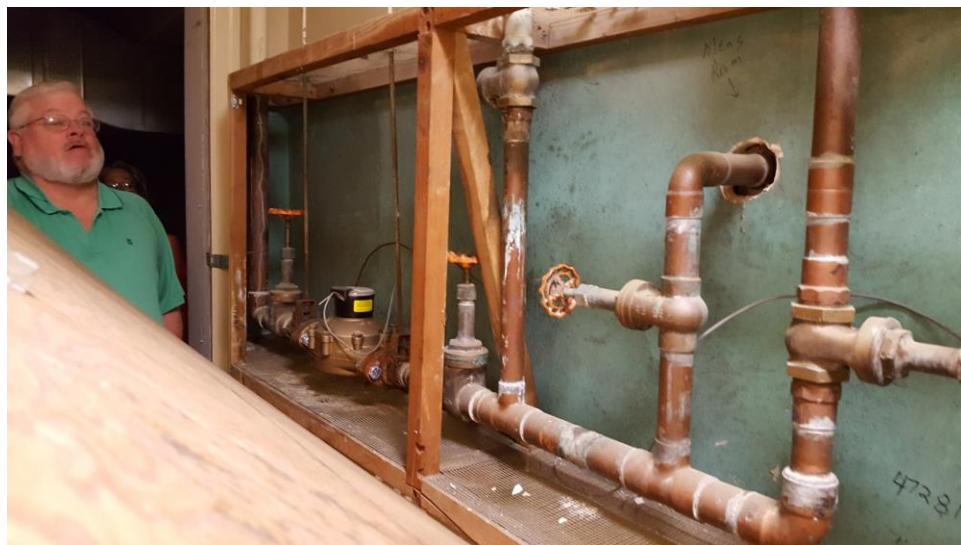
Figure 12: Domestic water piping and water meter

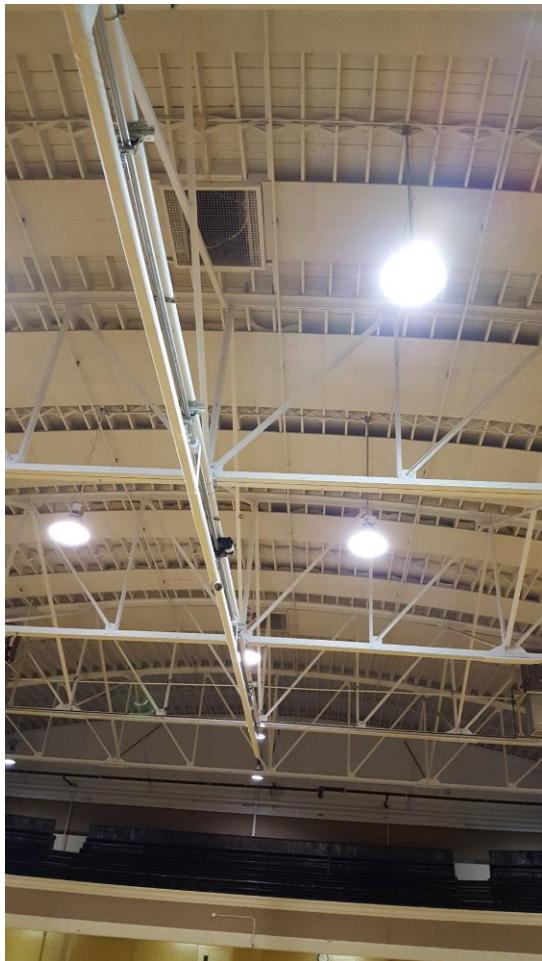
According to building operators, the facility has a new EPDM roof throughout. The underside of the roof is exposed in the Gym area. There does not appear to be any insulation on the underside of the roof deck. According to maintenance staff, the new roof was not provided with any additional insulation.

Figure 13: Underside of roof in Gym area

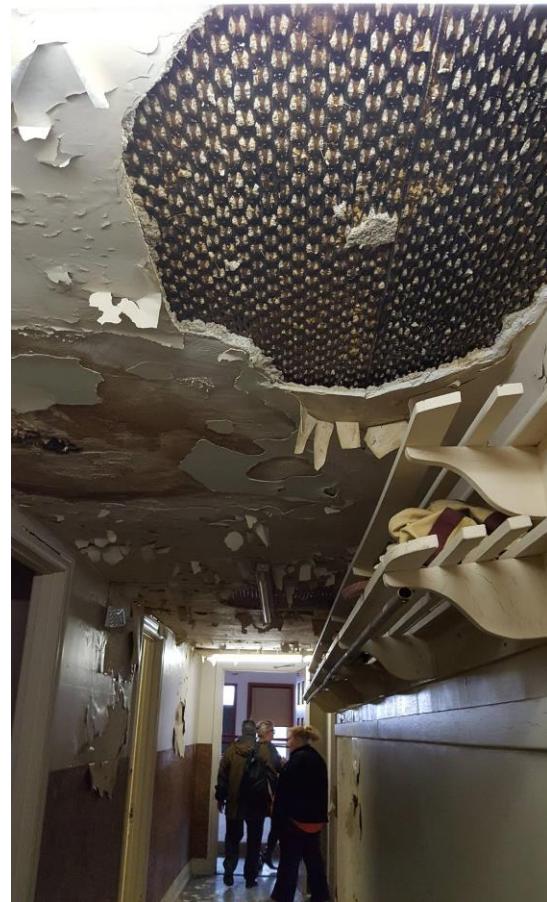
Figure 14: Water damage in second floor hallway

There is evidence of moisture intrusion into the occupied space on the second floor. Extensive water damage is apparent throughout the second floor. There does not appear to be much evidence of roof leaks that are still leaking. There was no standing water or catch basins inside the building. There was no dripping water present during our site visit, which was conducted during rainy weather conditions. The extent of the water damage is unclear. Additional investigation would be required to determine any structural damage. There was little evidence of apparent mold growth inside the building. This does not rule out the possibility of mold being present behind finished surfaces. Additional investigation would be required to rule out the presence of health affecting mold growth.

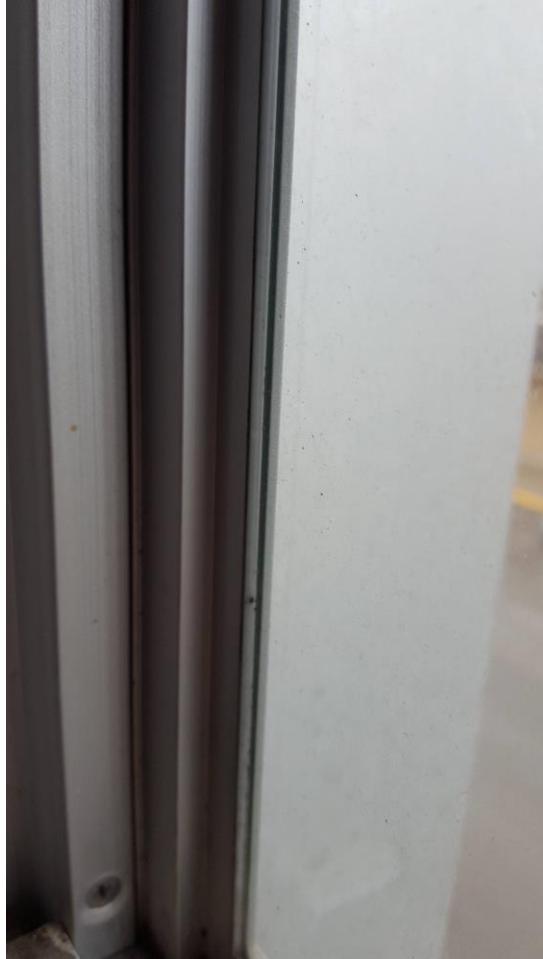
The original design included large windows on both sides of the Gym. These have since been removed and replaced with painted concrete brick. The windows on the office side of the building are 1/8" single pane glass. Seals around windows appear aged and degraded. The building also has two skylights. There is evidence of moisture intrusion around these skylights.

Figure 15: Close-up of existing window frame

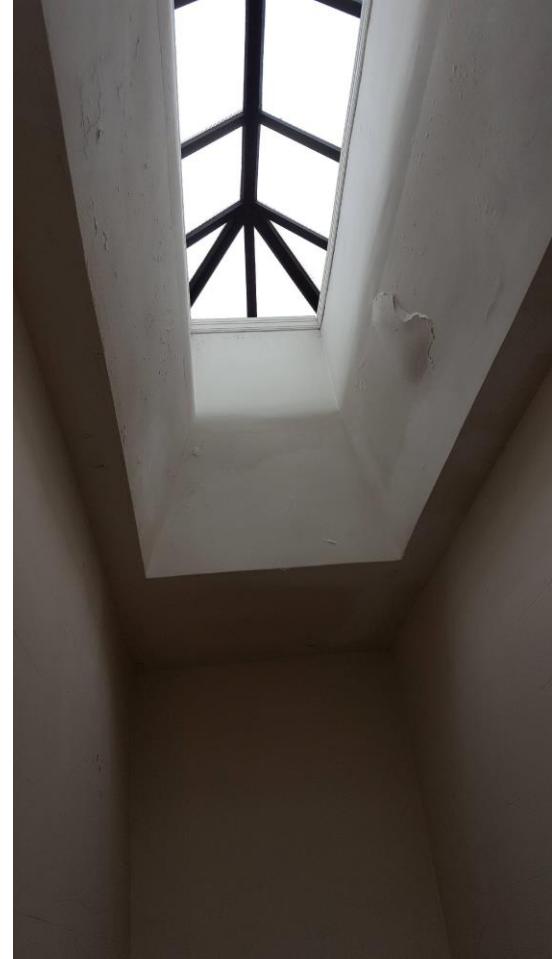
Figure 16: Water damage under skylight

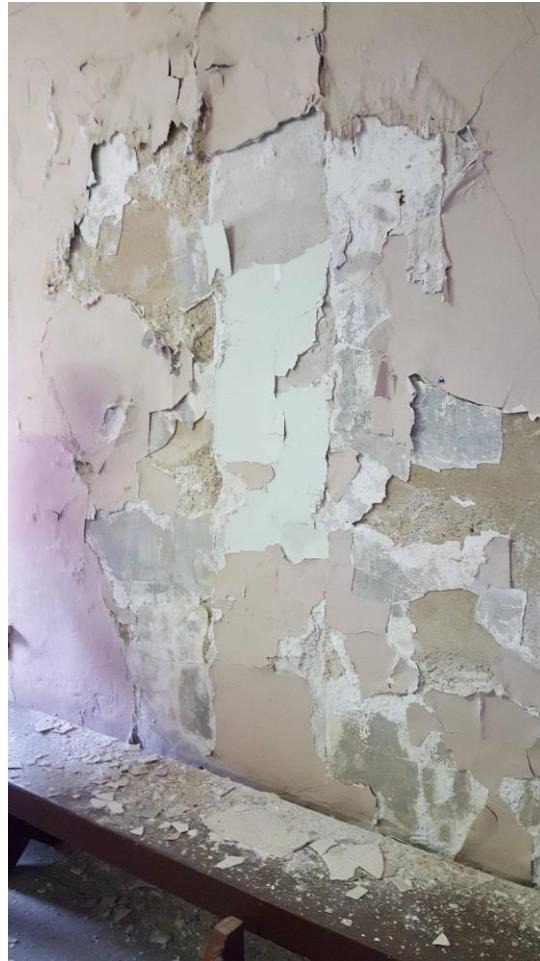
There is also some substantial moisture-based damage around the perimeter of the office area. This damage may be the result of roof leaks or moisture transfer through the exterior wall. This moisture transfer could potentially be caused by building negative pressure as a result of running the Gym exhaust fans without opening the exterior doors.

Figure 17: Water damage on East wall, second floor
